Manhole Inspection Summary

Manhole # S49II_002MH

Insp Date: **5/15/08 10:33 AM**

Location Address: **Federal st**

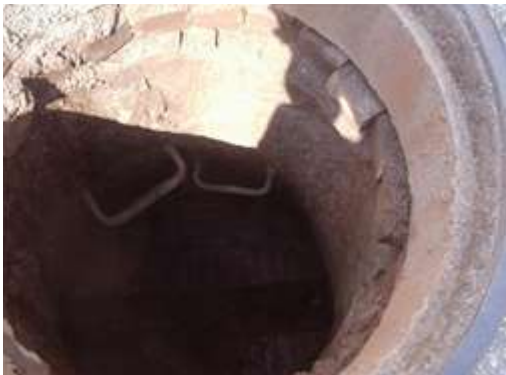
Defect 1

Condition: ☐ Sound ☐ Cracked ☐ Root Intrusion ☒ **Loose Brick** ☐ Deteriorated

loose bricks

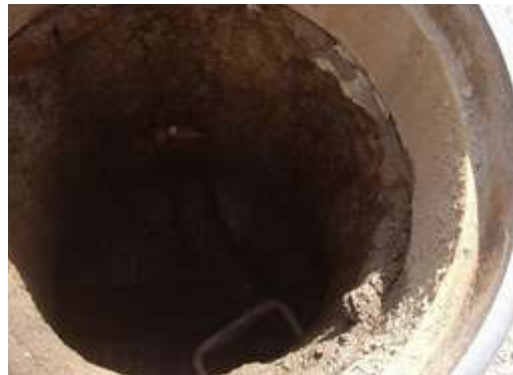
Defect 2

Infiltration: ☐ None ☒ **Joint** ☐ Cracks ☒ **Mortar** ☐ Roots ☐ Wall

infiltration

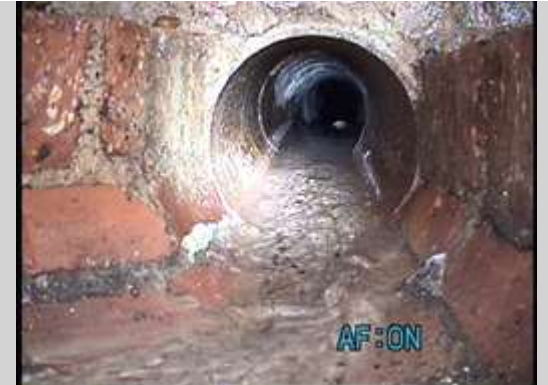
12 O'Clock Outflow

Pipe Height: **8.4** (in.) Rod and Bar (Angled)
Pipe Material: **Clay** ☐ Pipe Lined
Invert Depth: **8.30** (ft.) Flow Characteristics: **Fast**
Deposits: ☒ None ☐ Mud ☐ Sludge ☐ Debris ☐ Grease
Silt Depth: (in.) Deposits Extent:
Infiltration: **None** Pipe Seal Cond: **Sound**

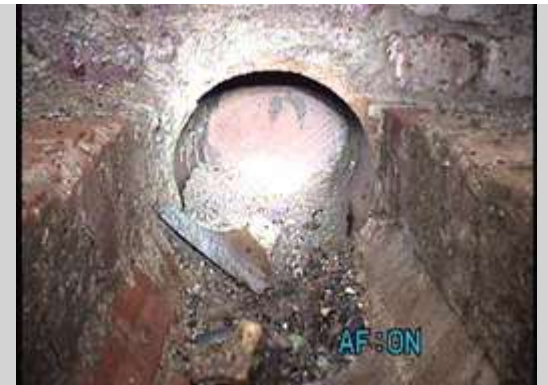
6 O'Clock Inflow

Pipe Height: **8.4** (in.) Rod and Bar (Angled)
Pipe Material: **Clay** ☐ Pipe Lined
Invert Depth: **8.05** (ft.) Flow Characteristics: **None**
Deposits: ☐ None ☐ Mud ☐ Sludge ☒ **Debris** ☐ Grease
Silt Depth: **1** (in.) Deposits Extent: **Light**
Infiltration: **None** Pipe Seal Cond: **Sound**

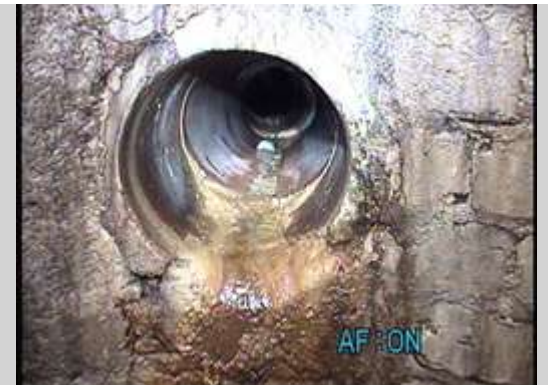
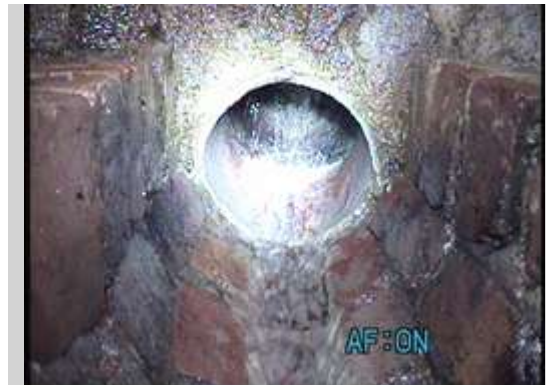
9 O'Clock Inflow

Pipe Height: **6** (in.) Rod and Bar (Angled)

Infiltration: **None** Pipe Seal Cond: **Sound**

Drop: **Inside**
